**Use of Geotextiles with Enhanced Lateral Drainage in roads over
expansive clays**

May 2015

Eight test sections with different geotextiles were constructed on State Highway 21 in Bastrop, Texas. The road is founded on expansive clays. A number of geotextiles, including one with enhanced lateral drainage capabilities, were incorporated to 500 feet long test sections. All sections were equipped with sensors to monitor moisture beneath the

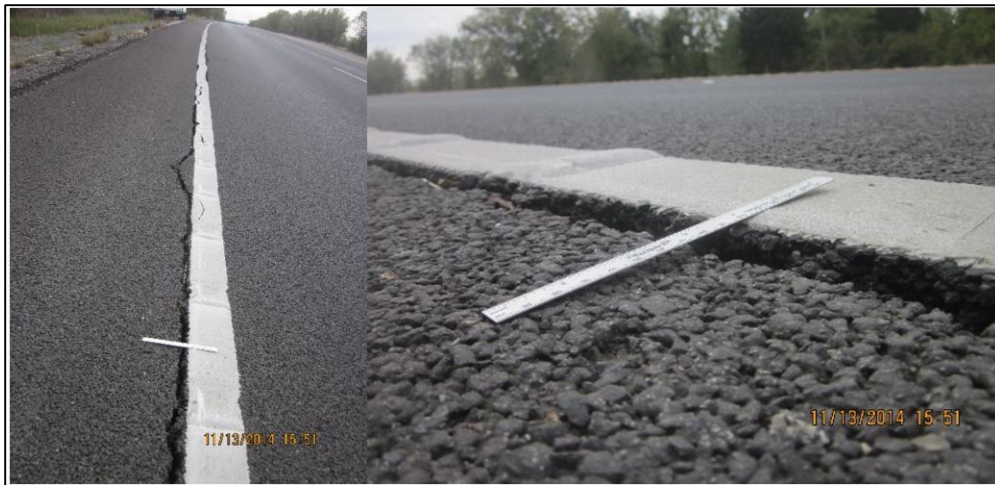
Figure 5.19: Pictures of Edge Crack in Section 7

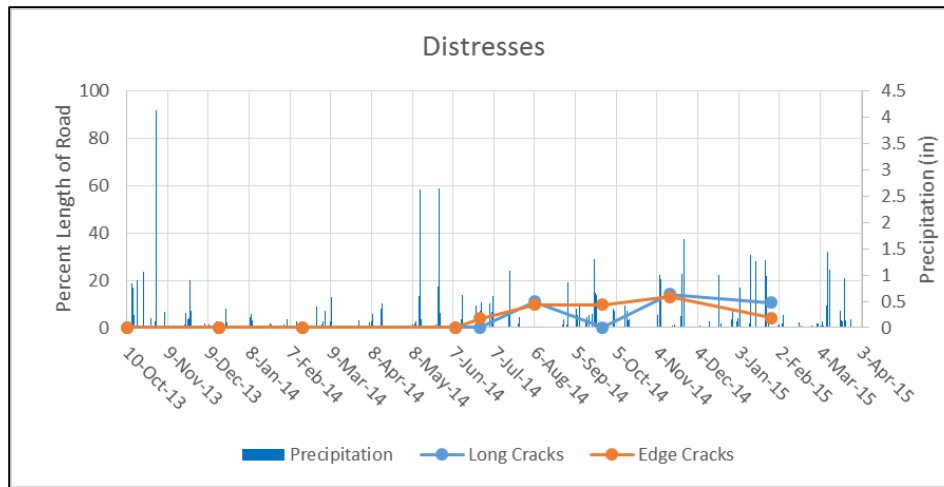
Figure 5.22: Summary of distresses in Section 5

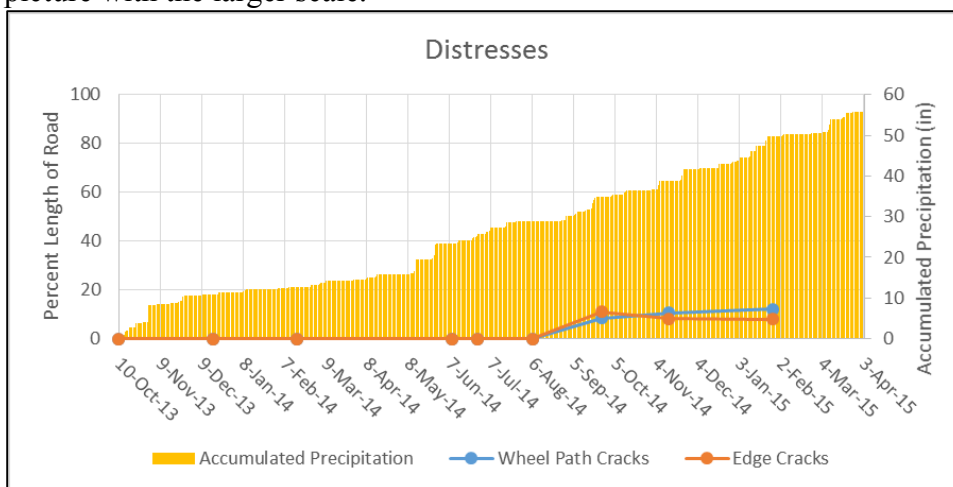
Figure 5.26: Summary of distresses in Section 4

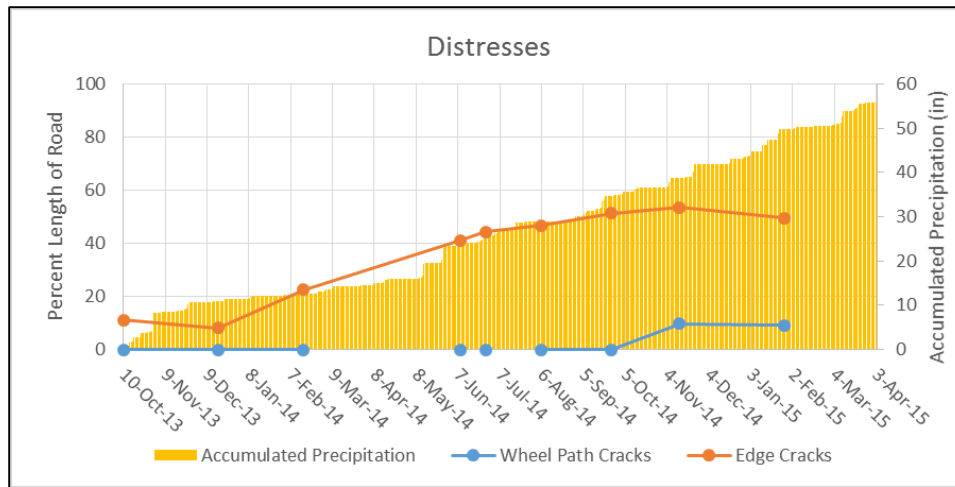
Figure 5.27: Summary of distresses in Section 7

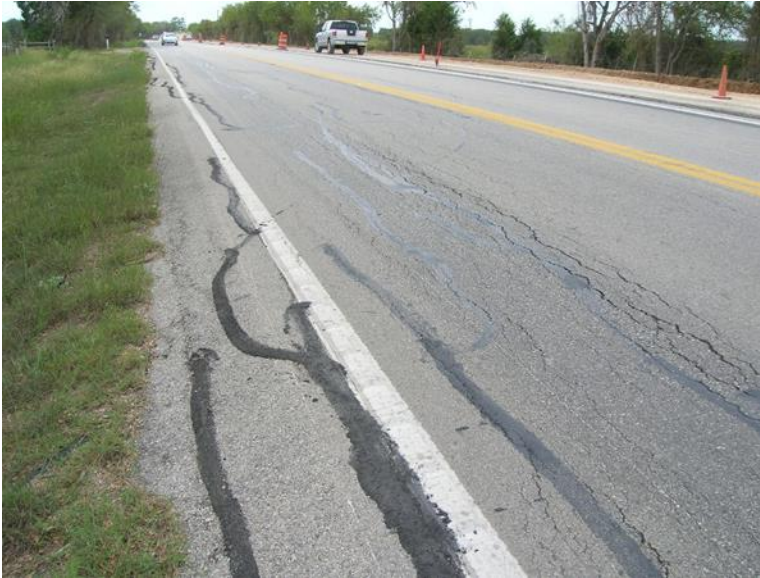
Figure A.1: Longitudinal cracks in SH-21 prior to repair

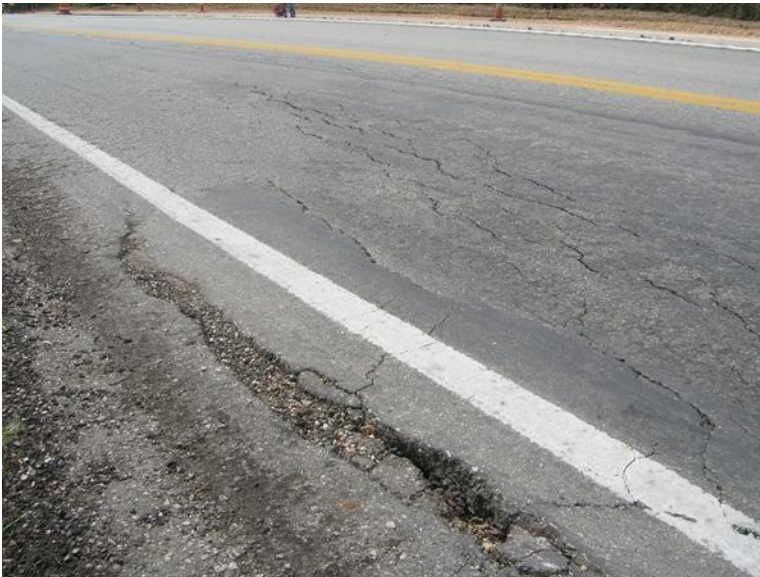
Figure A.2: Edge cracks in SH-21 prior to repair

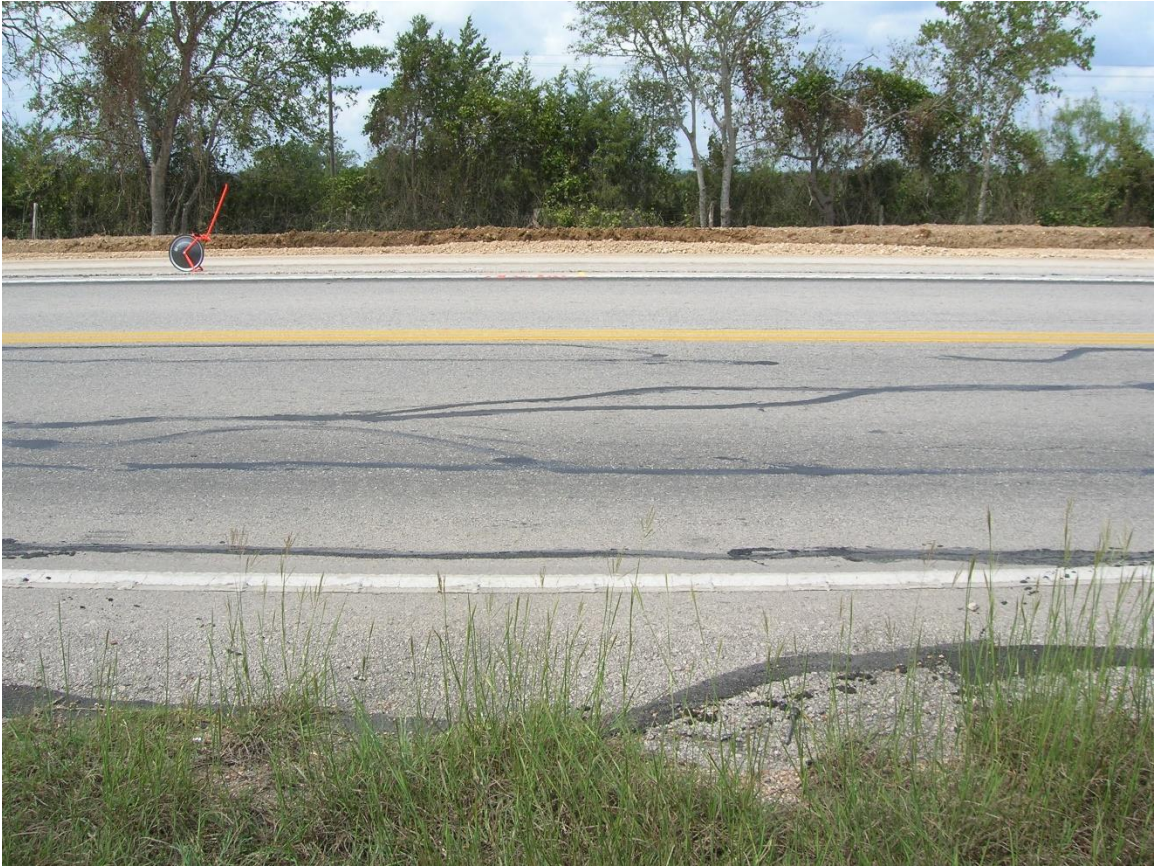
Figure A.3: Longitudinal cracks in SH-21 prior to reparation

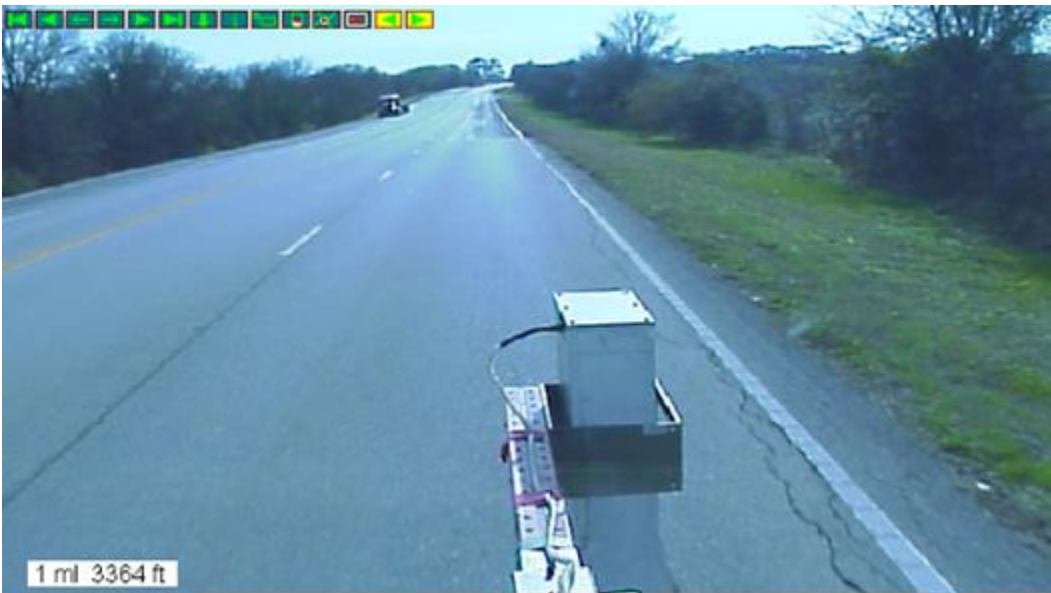
Figure A.4: Class 1 distresses in SH-21 (Texas Transportation Institute, 2010)

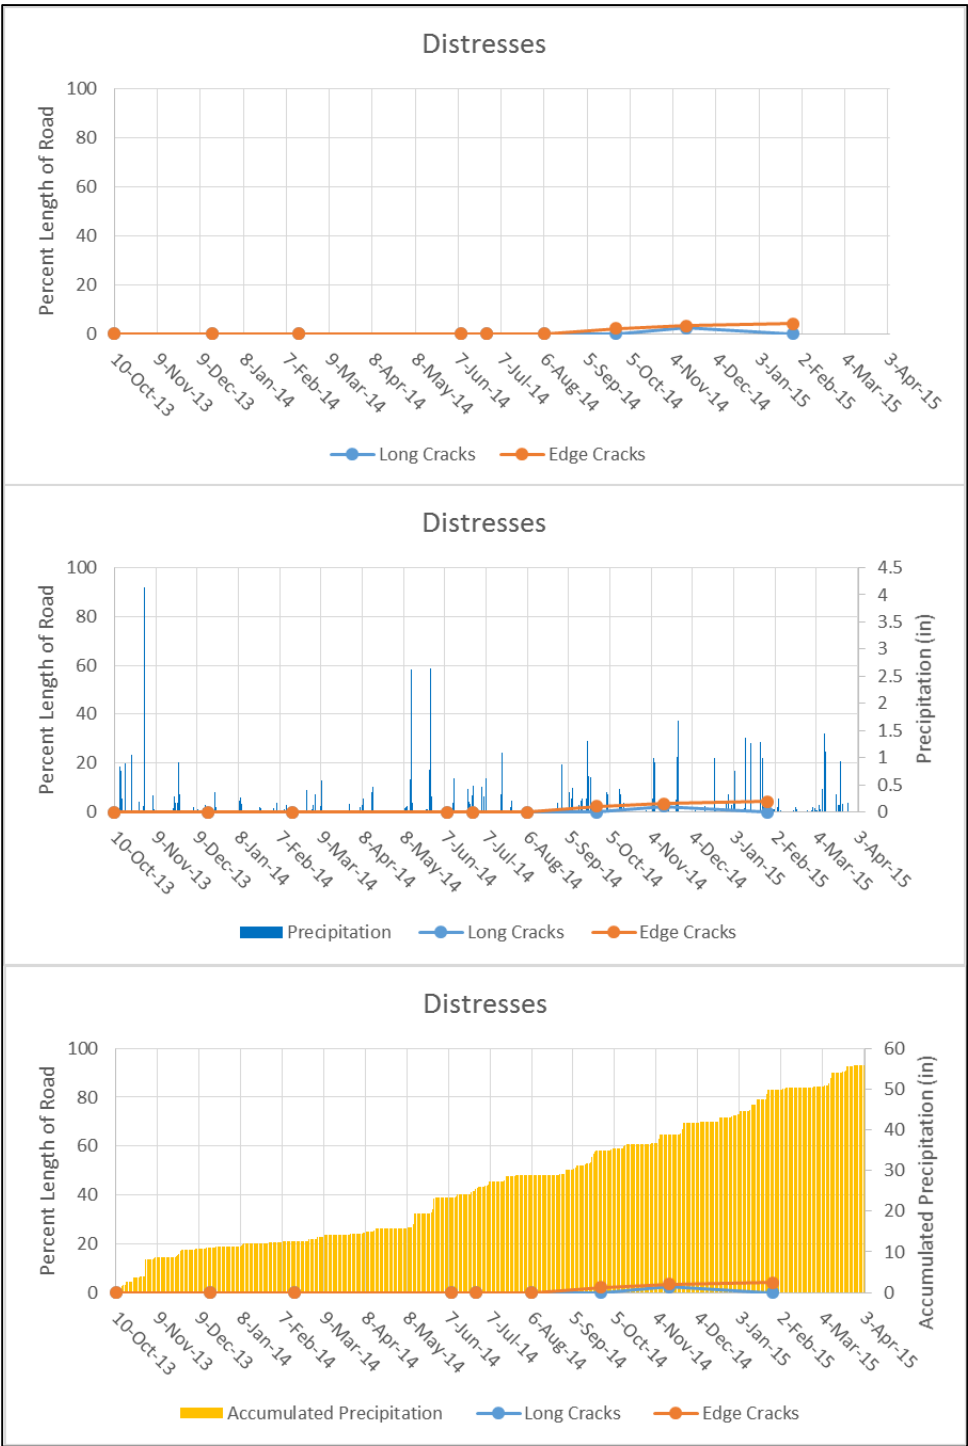
Figure B.1: Summary of distresses in Section 1
